Management of Apical Resorption in a Traumatized Upper Central Incisor: A Clinical Case Report

Naureen Rizvi

King's College Hospital, London

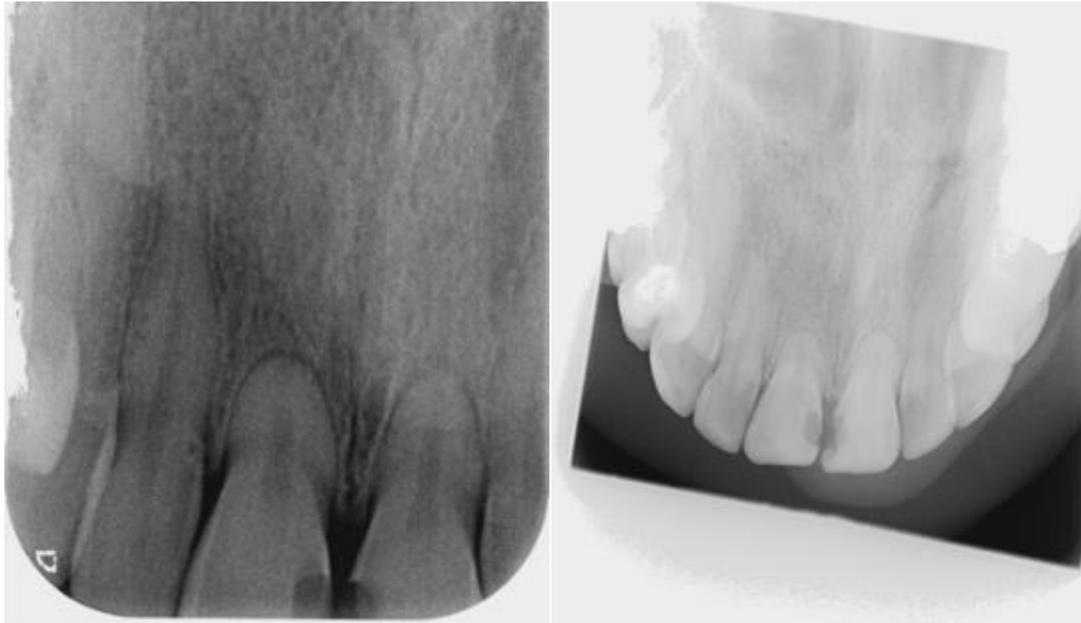
Fig. 2 Periapical radiograph of UR2, UR1, UL2. Fig. 3 Upper occlusal radiograph of UR2- UL2

Radiographs show mesial radiolucencies on the UR1 and UL1 (representative of composite restorations seen clinically). Crowns are intact with no fracture lines. The roots of UR1 and UL1 are short, with widening of the PDL space in the UL1 apical region. Good bone levels.

The patient had fallen and banged her front teeth at the age of 7 – which could explain the stunted roots of UR1 and UL1. There was no history of orthodontic treatment.

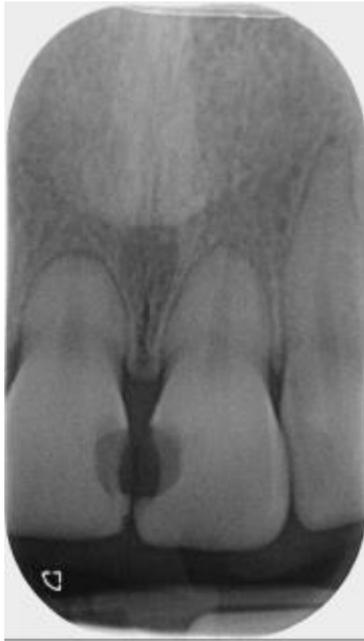
Figure 3. Periapical radiograph showing UL1 following repositioning and fixation with resin fluid.

Consent for repositioning was obtained and local anaesthetic with articaine infiltrations was administered. The UL1 was repositioned manually and held with finger pressure. Gel clear fluid resin was used to hold the tooth in position, before taking a check radiograph.

A 0.5mm flexible wire secured with composite was used to splint UR1, UR2, UL1, UL2 and the gel resin was removed.

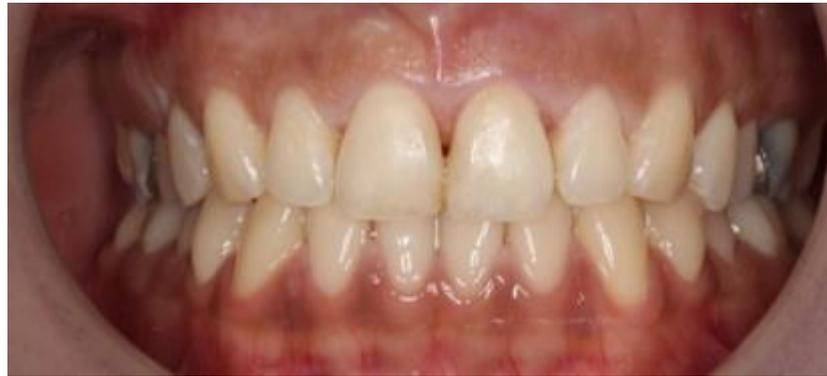
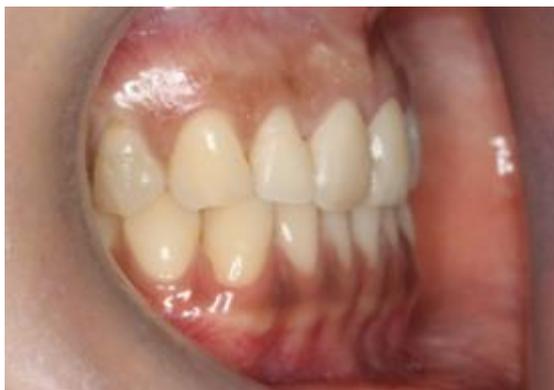
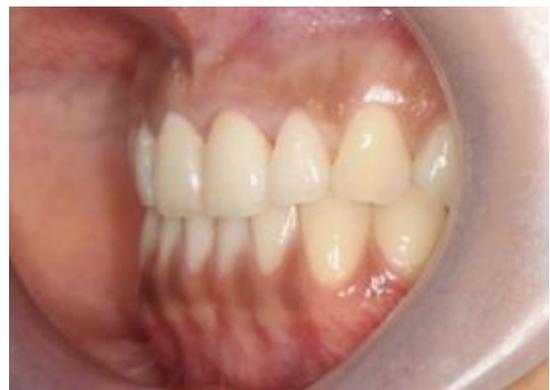
Fig. 5.1, 5.2 and 5.3. Following repositioning and splinting with flexible wire 2 weeks after injury.

The splint was removed in accordance with the IADT guidelines² 2 weeks later. There was no discolouration, all teeth responded positively to ethyl chloride and EPT, no mobility, no tenderness on palpation or percussion, no sinus or swelling.

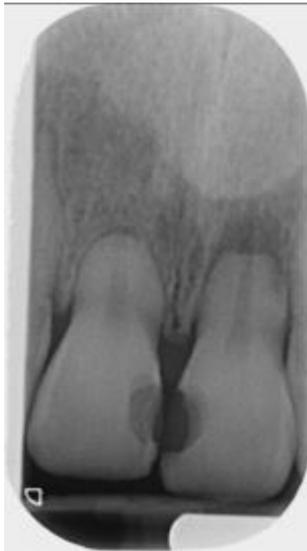
Figure 6. Periapical radiograph of UR1 and UL1

A periapical radiograph showed the UL1 was 1mm extruded, with apical resorption and radiolucency. Advantages and disadvantages of all treatment options were discussed with the patient and she preferred having endodontic treatment, whilst understanding resorption of the tooth may continue long term.

Mineral trioxide aggregate (MTA) was the material of choice; it may be considered as an ideal material for apexification, root perforations and retrograde filling due to its high compressive strength and high pH which can stimulate cementoblasts/ osteoblasts³.

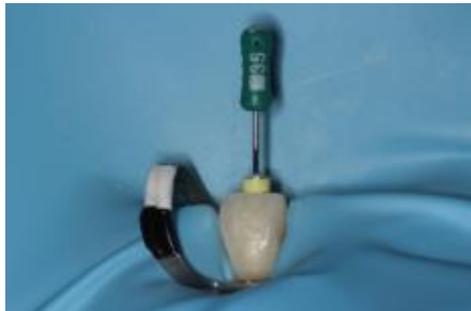
Fig. 7 Root canal treatment with hand files under rubber dam isolation

Root canal treatment was carried out, using irrigation with 3% sodium hypochlorite throughout. K-files were used to a working length of 14mm, confirmed with an apex locator. Non-setting calcium hydroxide was placed, and 1 week later the canal was re-instrumented, irrigated and dried with paper points. A Machtou plugger was used to fill the canal with MTA to just below the ACJ (beyond this would result in darkening of the tooth). The canal was sealed with glass ionomer cement.

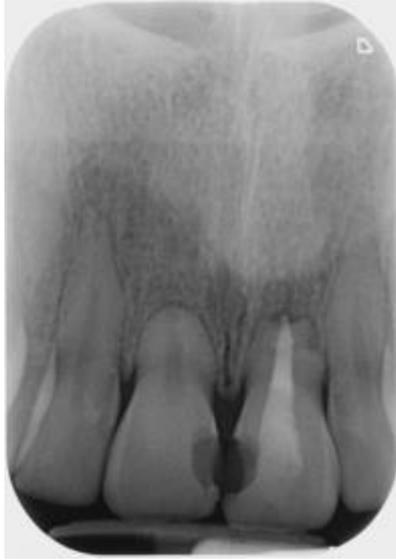
Fig. 10 periapical radiograph of UR1 and UL1 3 months after obturation with MTA.

An intra-oral periapical radiograph taken 3 months after obturation showed good resolution of the UL1 apical radiolucency. There did not appear to be any change in

the extent of resorption. A trauma stamp revealed no abnormalities and normal response to sensibility tests in adjacent teeth.
